**INSPECTION OF COMPOSITES USING A COMPUTER-BASED  
REAL-TIME RADIOGRAPHIC FACILITY**

by Ernest Roberts, Jr., and Alex Vary  
Lewis Research Center  
Cleveland, Ohio 44135

**TECHNICAL PAPER to be presented at the  
Second Conference on Automated  
Inspection and Product Control  
Chicago, Illinois, October 19-21, 1976**

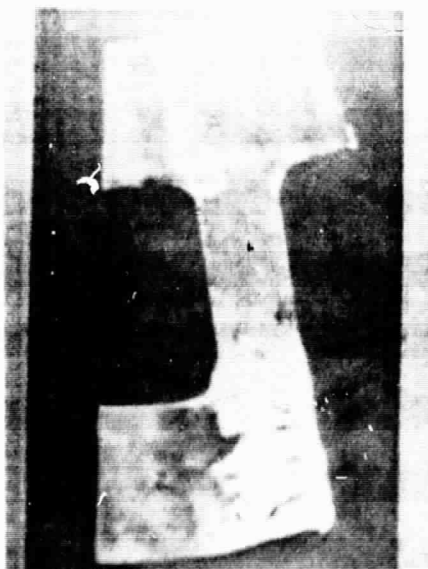
(a) ENTIRE OBJECT.

test was conducted at 2 MHz. The result is shown in figures 4(a) and 4(b). Figure 4(a) shows the scan of the entire object. Figure 4(b) is a close-up of the area of interest. Because of extensive delamination in the damaged zone, little information is apparent in that figure. However, it indicates the existence of damage, and shows its location and approximate extent.

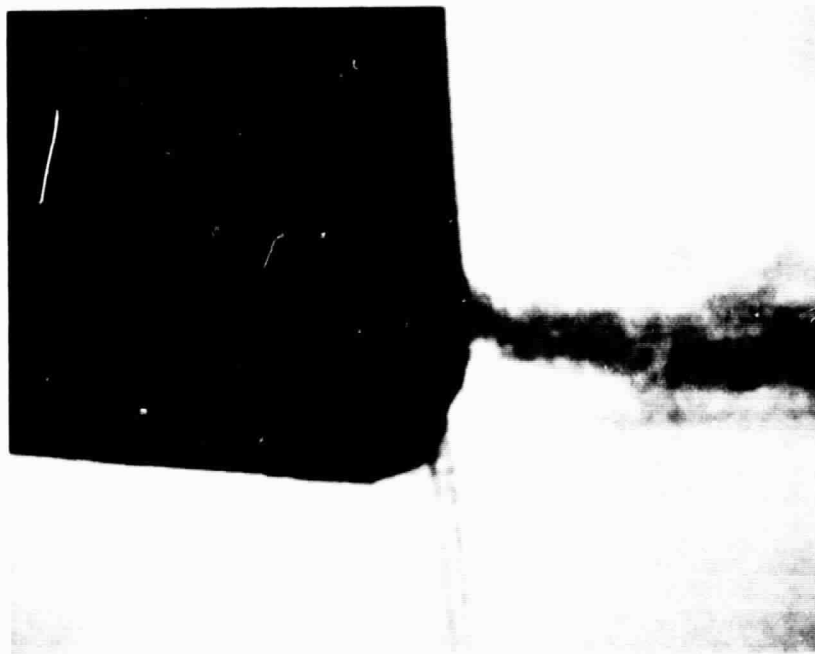
Figure 5. - Radiograph of damaged area.

More detail is produced by radiography. In this case, the radiography was done on opaque photosensitive paper, rather than film. A short exposure at low voltage produced the image shown in figure 5. It was produced in approximately 15 seconds at 50 Kv and 6 Ma. There was no filter, but an image intensifier screen was used with the paper. This method emphasized the major shortcoming of conventional radiography. The basic drawback is that intermediate steps must be taken before the image is available, introducing a time-delay.

The radiograph was much more informative. The irregularities known to exist in the test object were evident. Fine details were easily resolved, and there was little extraneous noise in the image. However, those advantages occurred at the cost of an interruption in the continuity of the manufacturing process: that is, a delay for photographic image development was required.
